# **J. ARONSTEIN**

## **HAZARDOUS FPE CIRCUIT BREAKERS AND PANELS**

*(Updated as of May 25, 2007)*

*Information for Inspectors and Homeowners*

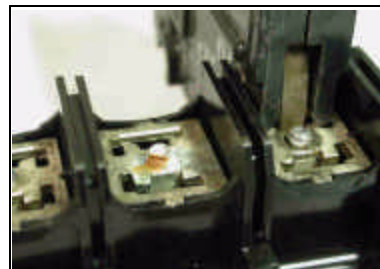
**C. Stab socket on a post, attached with an 8-32 steel screw.**

Of the three types illustrated, the one shown in Figure 2-C is known to have a high probability of deteriorating and overheating of the stab socket structures when subjected to significant current flow. Each individual stab socket plate is connected to its bussbar via a post (spacer), and the assembly is held together by an 8-32 steel screw. FPE panels with this construction are prone to overheating failure. The seven panels of the present study that showed evidence of serious overheating were constructed this way. One example is shown in Figure 3.

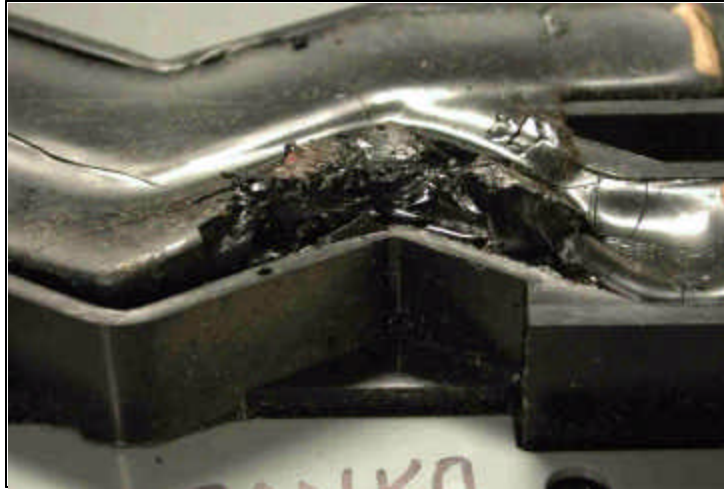
**FIGURE 3 - OVERHEATING AT THE CONTACT BETWEEN THE BUSSBAR AND THE STAB SOCKET ASSEMBLY CAUSED THIS DAMAGE TO THE INSULATION.**

(This view is of the backside of the panel. The damage cannot not be seen unless the panel is taken out of the enclosure.)

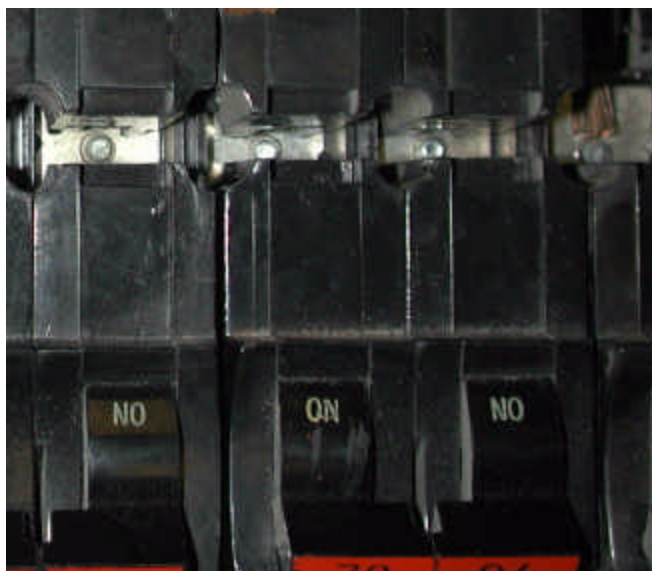
Inspectors can, however, determine if a particular FPE panel has this type of construction, and, to a limited extent, whether it has failing bussbar interconnections that have previously overheated. With the panel cover off, for this type of panel, you can see the ends of the screws holding the stab socket plate as shown in Figure 5. (Note: If you see slotted screwheads, that's a different type of panel construction.) The stab socket plates and the visible ends of the screws should have a bright metallic look. Darkening, discoloration, or signs of corrosion most likely indicate past episodes of abnormal overheating.

**FIGURE 5 - THE ENDS OF THE SCREWS HOLDING THE STAB SOCKET PLATES ARE VISIBLE BETWEEN THE TWO ROWS OF BREAKERS. THIS IDENTIFIES IT AS A PANEL OF THE TYPE SHOWN IN FIGURE 2-C**

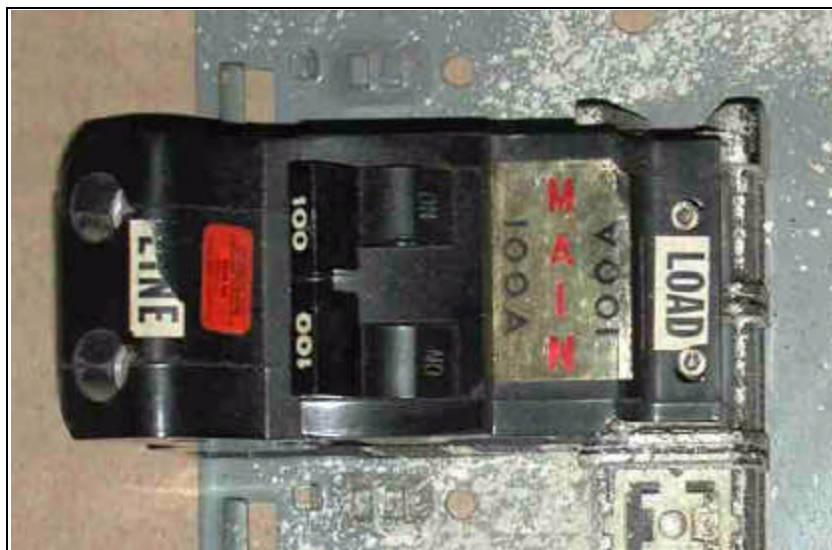
Some FPE Stab-Lok® panels have 100-amp main breakers that feed into the bussbars through the same plate and post system. In this design, the two main breaker output terminals do not have the stab type contact. Instead, each one is screwed down to a plate the same size as the stab socket plate, but which has a threaded hole in it instead of the stab openings. As with the plate and post assembly, the screws clamping the main breaker terminals are size 8-32, which is absurdly small for clamping the terminals of a 100-amp main breaker.

**FIGURE 6 - FPE 100-AMP MAIN BREAKER CONNECTS TO THE BUSBARS THROUGH THE PLATE & POST CONFIGURATION, USING ONE SOCKET-HEAD 8-32 SCREW AT EACH TERMINAL TO ATTACH TO THE CONTACT PLATE.**

**(The heads of the 8-32 terminal clamping screws are seen above and below the "LOAD" label.)**

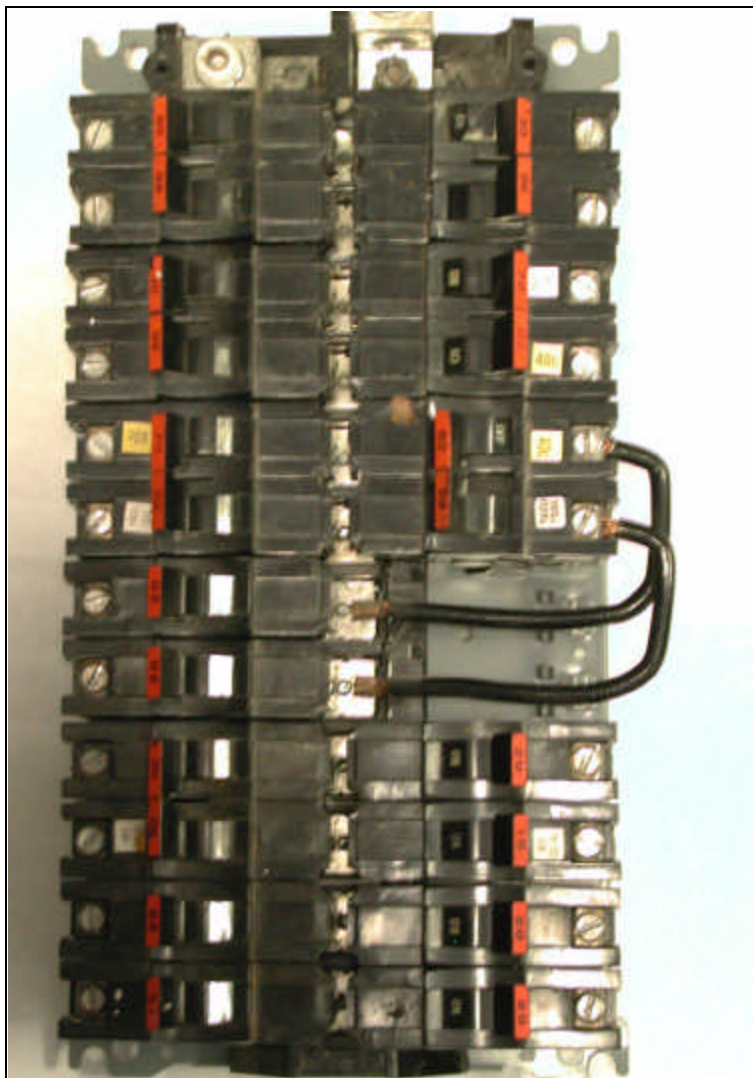
**FIGURE 8 - FPE STAB-LOK® "RULE-OF-SIX" (SPLIT-BUS) PANEL WITH NO MAIN BREAKER. THE JUMPER CABLES ON THE RIGHT SIDE FEED THE LOWER SECTION.**

There are many different design variations, but the essential element is that in these "rule of six" panels there is no main breaker, and, typically, the lower section of the panel is fed from jumpers coming from the output of one of up to six double-pole breakers in the upper section. The FPE Stab-Lok® double pole breakers have a relatively high probability of jamming when called on to trip, however, as previously demonstrated by the test results presented in Section 2. That means that the home with an FPE "rule-of-six" panel has an unacceptably high probability of having one or more circuits that are totally unprotected, in which the maximum current flow is only limited by what the transformer on the pole can deliver. This is likely to be of the order of 1,000 Amps or more.

On first glance, the FPE Stab-Lok® panel previously shown in Figure 8 looks normal. In fact, however, it clearly demonstrates several of the hazardous failure modes discussed in the previous sections. It is one of 28 collected for the recent testing. It is from a home built in 1974, whose new owners had determined in 1999 that it should be replaced. Their decision to replace it was in part prompted by information available on the internet regarding FPE breaker problems.<sup>7</sup> According to the homeowner, who sent it to me for examination and testing, *"We recently had it replaced and found the breaker to the dryer fried in just the way described. Our electrician was astonished. Two others we had bids from dismissed our concerns with contempt."*<sup>8</sup>

There are additional problems in this panel. Overheating damage occurred to the insulation on the backside of the panel. Further, in addition to the dryer breaker that failed (jammed) in the home, two other two-pole breakers from this same panel failed in the lab testing. All this in a panel that looked OK from the front!

Everything in the home was functioning. The dryer worked. Why wouldn't it, since the circuit breaker was jammed with its contacts closed? Keep in mind that this panel is one of the "rule-of-six" configuration. Before they replaced this panel, the homeowners unknowingly had a situation where, essentially, the clothes dryer was wired straight through to the power line transformer on the pole, with no functional circuit protection at all.

There is no question but that the FPE Stab-Lok® panels should be replaced. There is no practical and safe alternative.

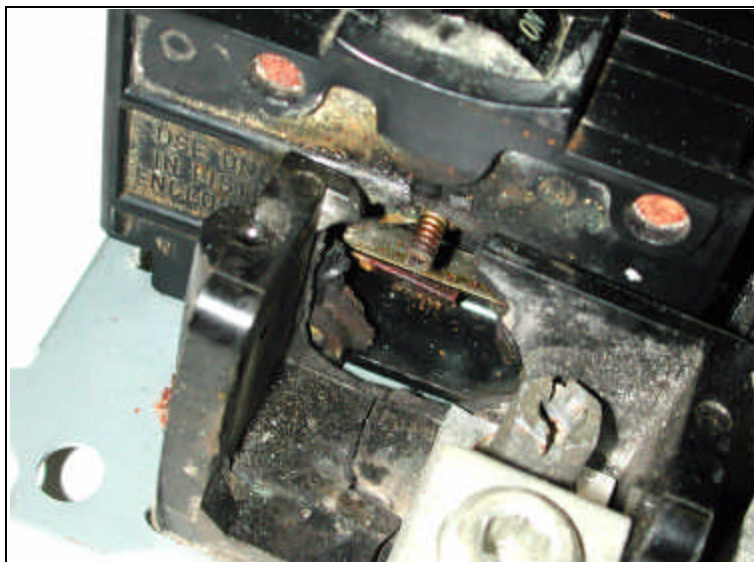
**FIGURE 9 - VIEW DOWN TOWARD UPPER RIGHT OF PANEL SHOWN IN FIG. 8.**

Viewing the panel from the front, some subtle signs of overheating (as previously discussed) are evident. These are subtle compared to the view looking down at the top right (dryer) breaker, as in Figure 9. The main service cable connector has been rotated out of the way for better visibility of the damage. The plastic insulator is burnt and cracked. The breaker's internal mechanism can be seen through the hole burned through its side. Figures 10 and 11 show the damage to the separate items.

**THE FPE STAB-LOK® TWO-POLE 30-AMP BREAKER FED THE CLOTHES DRYER.**

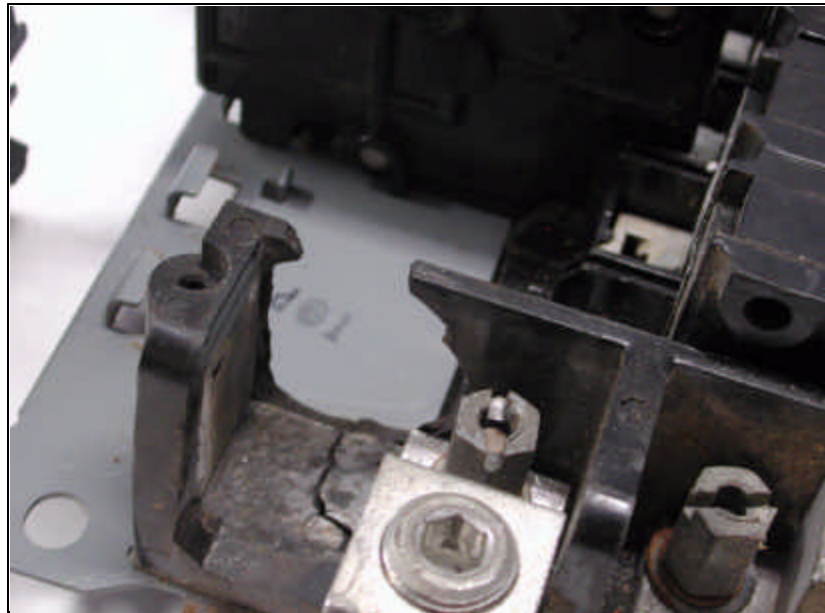
**FIGURE 10** - THE DAMAGE TO THE INSULATING STRUCTURE OF THE PANEL (FIG. 8) IS MORE CLEARLY VISIBLE WITH THE BREAKER REMOVED.

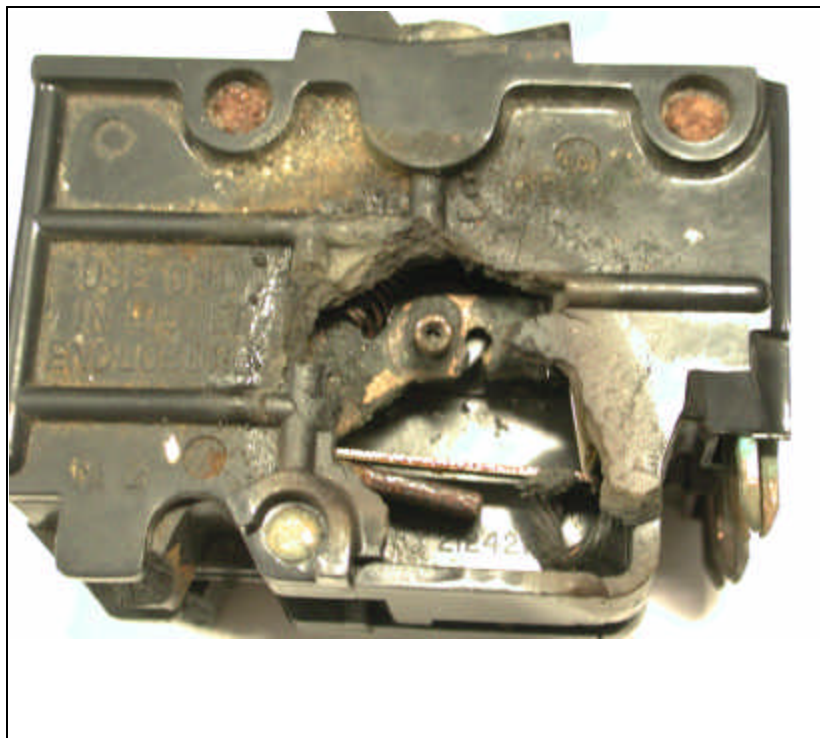
**FIGURE 11** - THE FAILED FPE STAB-LOK® DRYER BREAKER (UPPER RIGHT, FIG. 8)

The damage to the breaker, from some previous short circuit or failure event, is exactly as had been demonstrated in the tests done for CPSC.<sup>2,3,4</sup> Those tests demonstrated that, when an FPE breaker jammed and the current exceeded about 300% of the breaker's rating, the side of the breaker disintegrated and/or ignited from the heat being generated within the breaker. This is due to resistive heating of the breaker's internal current-carrying components, mainly the bimetal element and the flexible copper braid that connects to it. This is not an arcing failure, although the damage to the insulating materials of the breaker and panel sets the stage for an arcing fault to occur.
