# **J. ARONSTEIN**

## **HAZARDOUS FPE CIRCUIT BREAKERS AND PANELS**

*(Updated as of May 25, 2007)*

*Information for Inspectors and Homeowners*

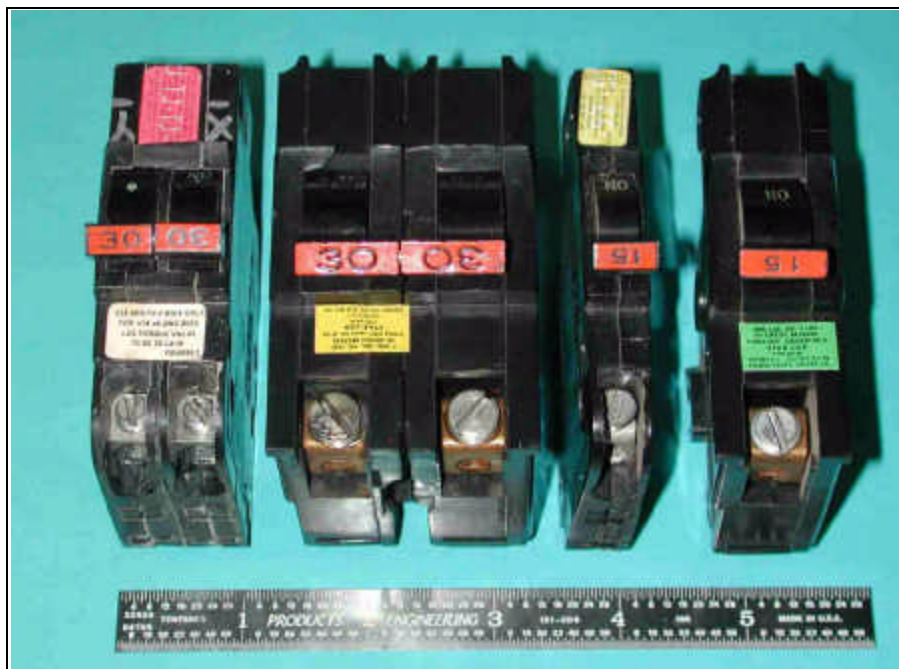
**FIGURE 1 - REPRESENTATIVE SAMPLES OF HALF- AND FULL-WIDTH FPE STAB-LOK® CIRCUIT BREAKERS** (left to right: 1/2-width double pole, full-width double pole, 1/2-width single-pole, full width single-pole)  
*Note that the color and style of the handle varied over the years.*

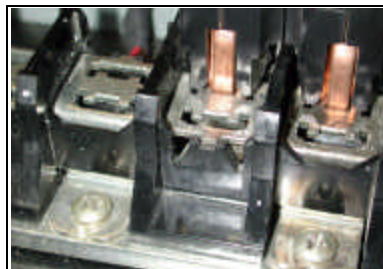
**B. "Z" clip, clamped to . bussbar with 10-32 screw.**

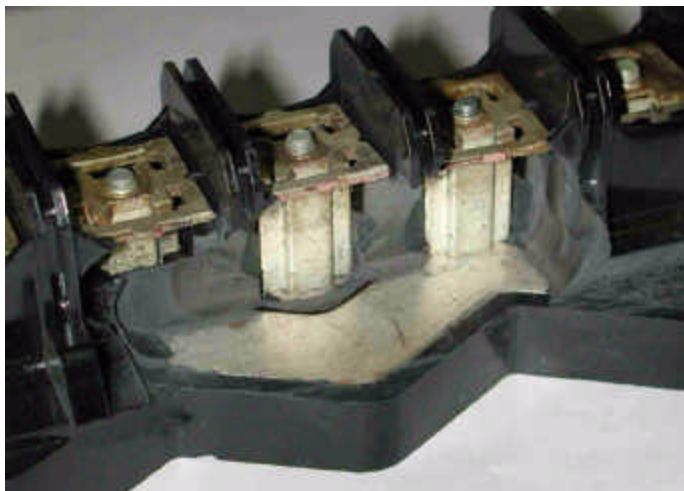
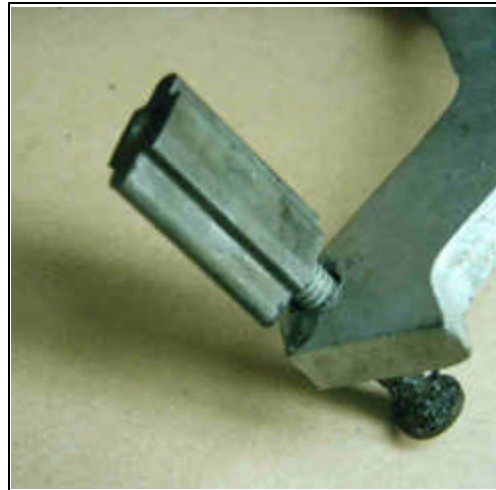
**FIGURE 4 - CONDUCTING PATH FROM BUSSBAR TO STAB SOCKET**

A more serious failure of this type has been documented.<sup>1</sup> In that instance, the failure had been severe enough to ignite a smoldering fire on the plastic insulating material. The fundamental weakness in this design is the use of a single, relatively flimsy 8-32 screw to hold a structure together that can feed up to four half-width breakers with a total "ampacity" (rated circuit capacity) up to about 160 Amps. Figure 4 shows how the stab socket plate and post are attached to the bussbar.

**A. Cutaway - Bussbar, Post, and Stab Socket Plate.**

**B. Bussbar, Screw, and Post**
